# HOME INSPECTION REPORT

Any Street  
Anywhere, USA

Prepared for: John Q. Public

Prepared by: Great Plains Inspections, LLC  
1042 44th Avenue West  
West Fargo, ND 58078  
[www.greatplainsinspections.com](http://www.greatplainsinspections.com)  
(701) 799-6459

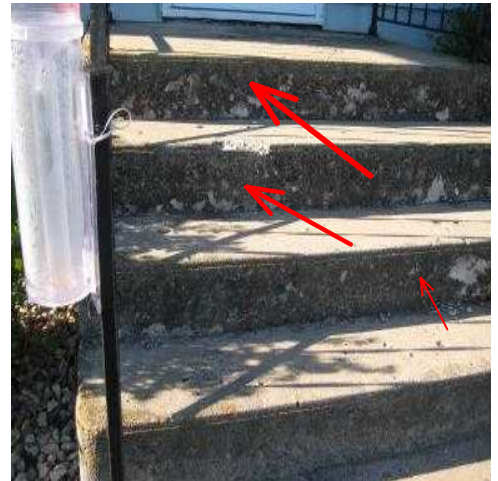
- A N P N I M D
1.      Driveway: Concrete
  2.      Walks: Concrete
  3.      Steps: Concrete Cracked and pitted areas on Steps. This is mostly cosmetic. Recommend evaluation by qualified contractor and repair as needed.
  4.      Stoops: Concrete

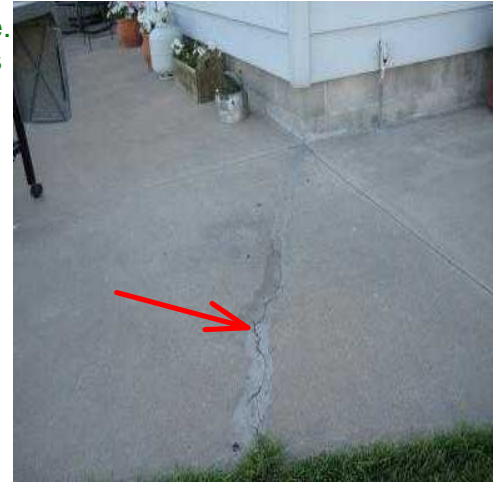
5.      Patio: Concrete **Cracked and patched concrete.**  
**This type of cracking is not unusual or a serious defect. Recommend patching by a qualified person as required.**

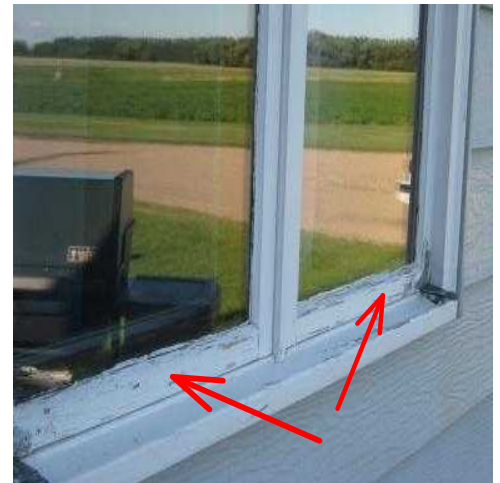
11.  Windows: Wood Casement, Double Hung  
Cracked and peeling paint on window frames. Recommend evaluation by a qualified person and repaint and repair as needed.

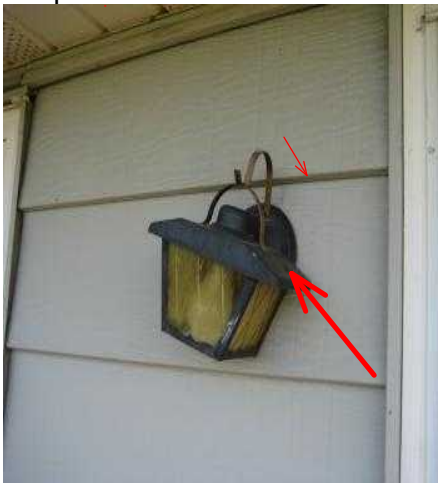
- 19. Is the panel bonded?  Yes  No
  - 20.      Door Bell: Hard wired
  - 21.      Smoke Detectors: Hard wired with battery back up
  - 22.      Exterior Lighting: Surface mount **light fixture next to South entry door is loose. Recommend a licensed electrician evaluate and repair or replace as needed.**

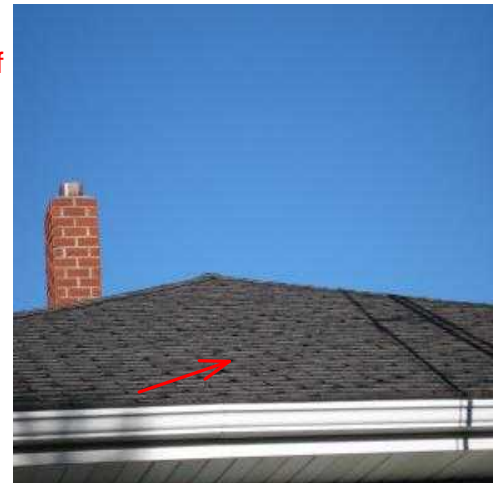
1. Method of Inspection: On roof
2.  Unable to Inspect: 0 %
3.  Material: Asphalt shingle Observed cracking and curling of shingles. They are near the end of their useful life. Recommend a qualified roofing contractor evaluate and estimate replacement cost.

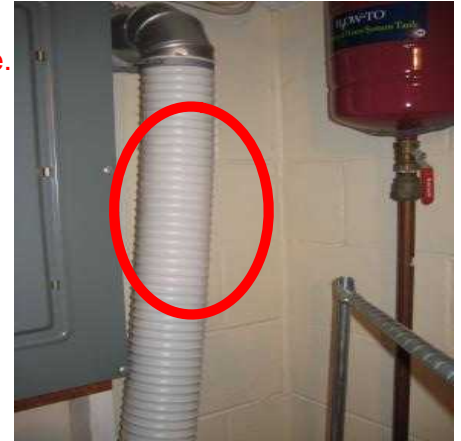
11.  Dryer Vent: Plastic flex **The plastic flex vent needs to be replaced with a metal flex or metal pipe. This is a safety hazard.**

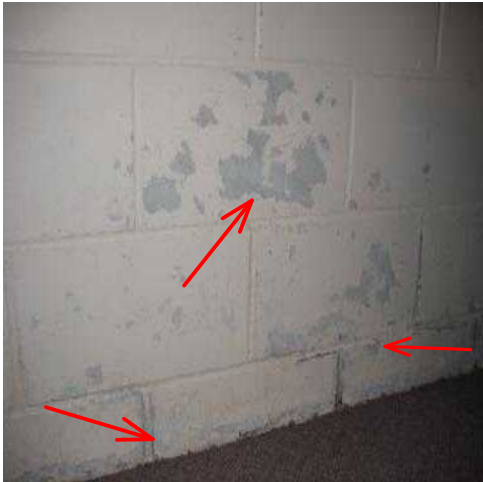
1.  Unable to Inspect: 0 %
2.  Ceiling: Paint
3.  Walls: Paint and paneling **Observed loose and peeling paint on the East, South, and West walls in the Family Room. This appears to be from past water intrusion. The owner has added drain tile and an additional sump pump recently to correct this. I recommend that a qualified contractor evaluate and determine if further improvements are needed.**

- 4.      Floors: Carpet, Tile
- 5.      Ventilation:
- 6.      Insulation:
- 7.      Vapor Barrier:
- 8.      Moisture Location: East, South, West **Signs of past water intrusion on East, South, and West walls near the floor. Drain tile and an additional sump pump have been added recently and should reduce the risk of future water intrusion. A qualified contractor should evaluate and determine if additional measures are needed.**

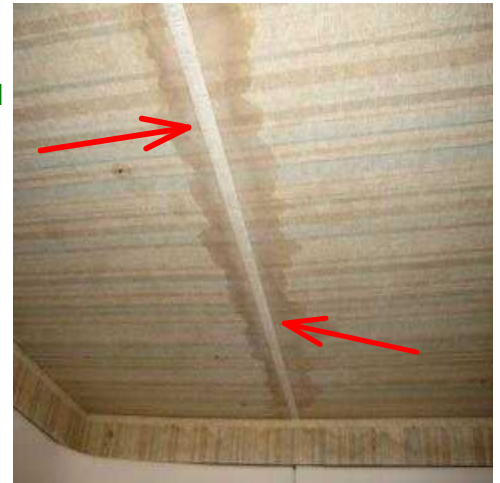
15.  Shower/Surround: Fiberglass pan and fiberglass surround **The ceiling of the shower in the basement has moisture damage. A qualified contractor should evaluate and replace or make repairs.**

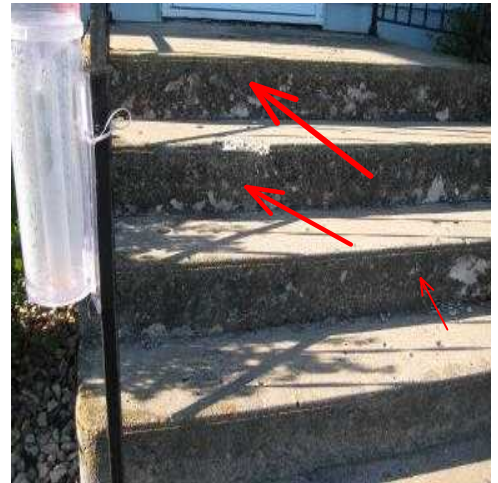
1. Steps: Concrete Cracked and pitted areas on Steps. This is mostly cosmetic. Recommend evaluation by qualified contractor and repair as needed.

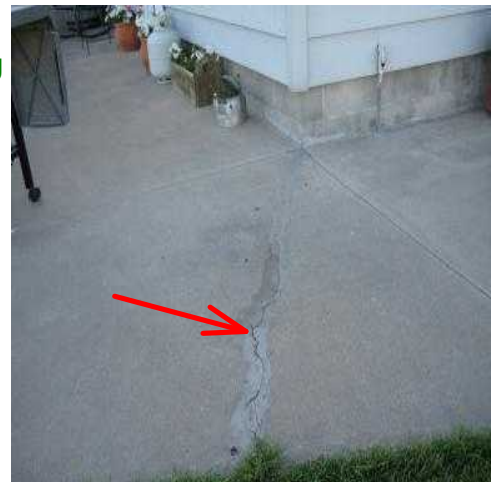
2. Patio: Concrete Cracked and patched concrete. This type of cracking is not unusual or a serious defect. Recommend patching by a qualified person as required.

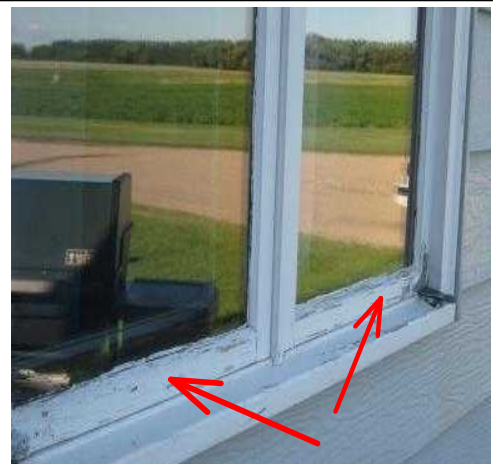
3. Windows: Wood Casement, Double Hung Cracked and peeling paint on window frames. Recommend evaluation by a qualified person and repaint and repair as needed.

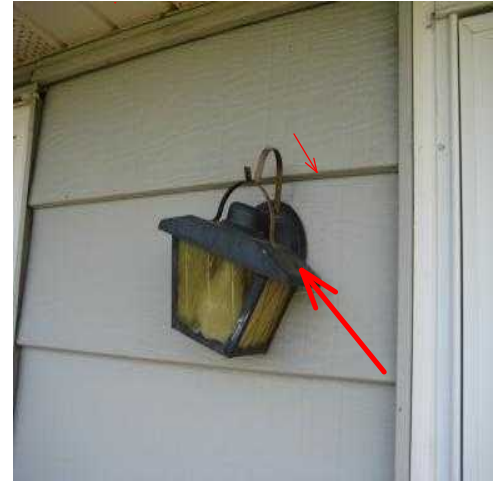
5. Exterior Lighting: Surface mount light fixture next to South entry door is loose. Recommend a licensed electrician evaluate and repair or replace as needed.

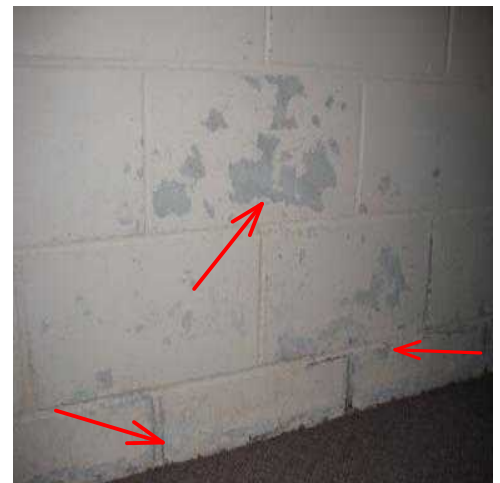
7. Walls: Paint and paneling Observed loose and peeling paint on the East, South, and West walls in the Family Room. This appears to be from past water intrusion. The owner has added drain tile and an additional sump pump recently to correct this. I recommend that a qualified contractor evaluate and determine if further improvements are needed.
8. Moisture Location: East, South, West Signs of past water intrusion on East, South, and West walls near the floor. Drain tile and an additional sump pump have been added recently and should reduce the risk of future water intrusion. A qualified contractor should evaluate and determine if additional measures are needed.

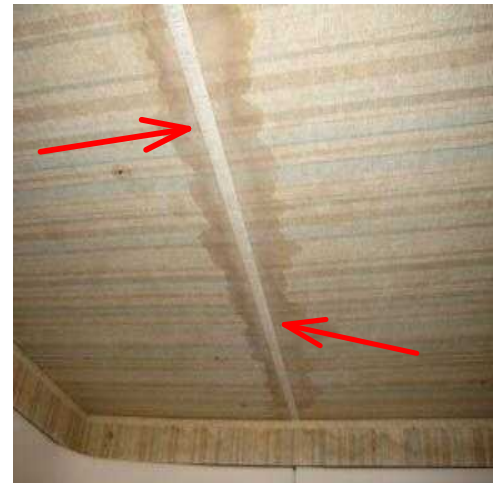
10. Shower/Surround: Fiberglass pan and fiberglass surround  
The ceiling of the shower in the basement has moisture damage.  
A qualified contractor should evaluate and replace or make repairs.

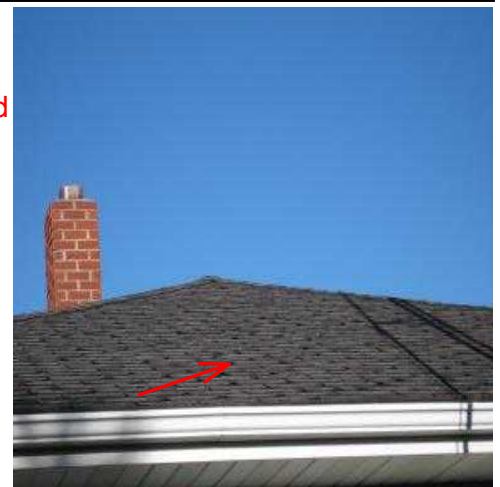
2. Main Roof Surface Material: Asphalt shingle **Observed cracking and curling of shingles. They are near the end of their useful life. Recommend a qualified roofing contractor evaluate and estimate replacement cost.**

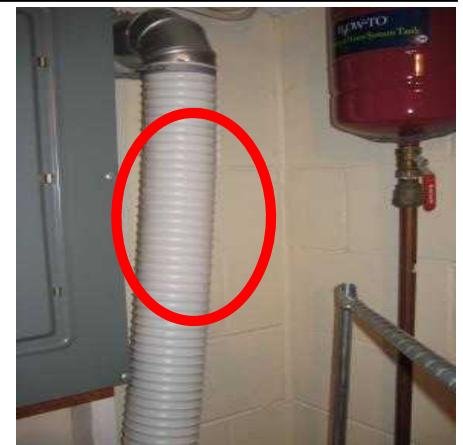
4. Dryer Vent: Plastic flex **The plastic flex vent needs to be replaced with a metal flex or metal pipe. This is a safety hazard.**
